| CONNECTICUT RIVER FLOOD CONTROL | | | |
| CLARK DIKE | | | |
| REPAIR & COMPLETION FROM STA. 3+00 TO 117+00 | | | |
| TYPICAL SECTIONS AND DETAILS | | | |

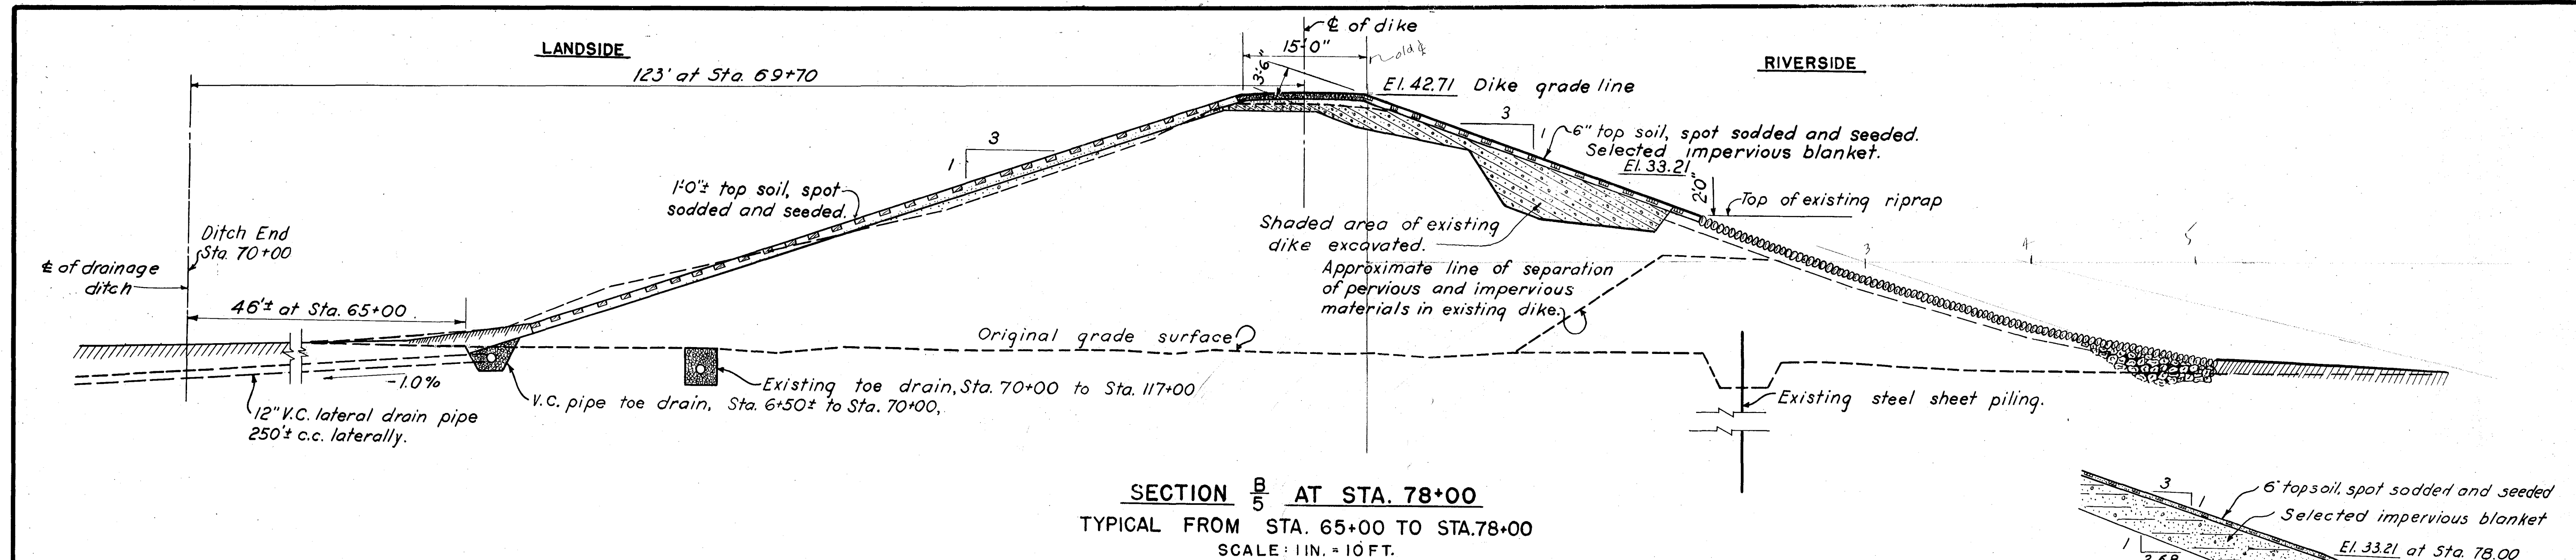
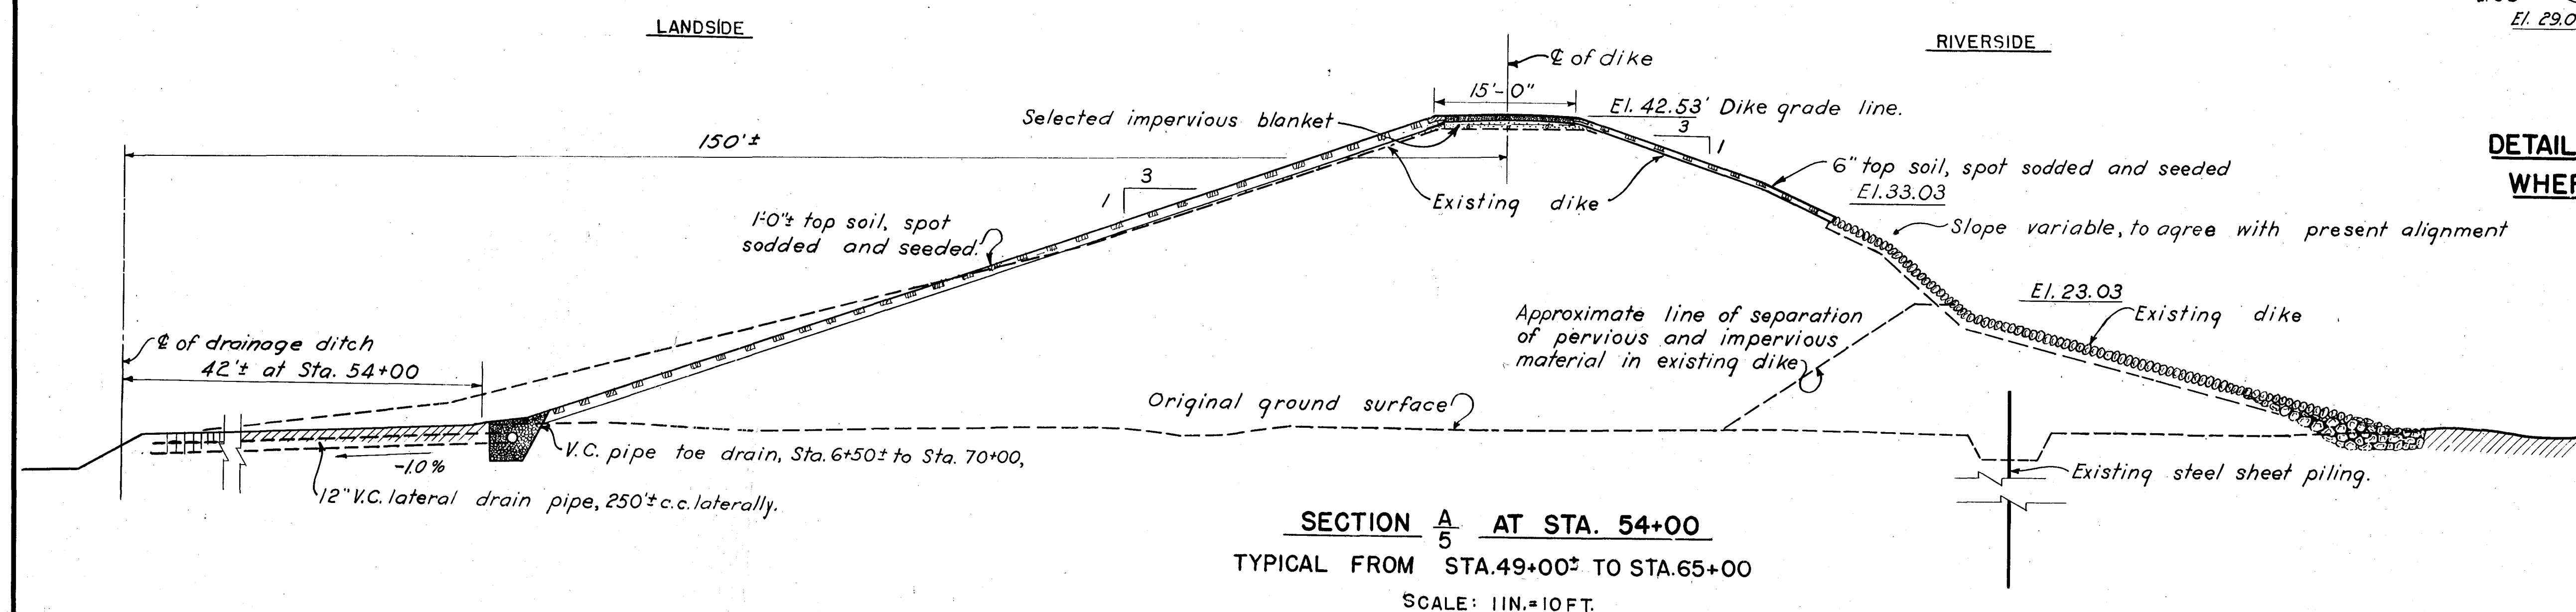
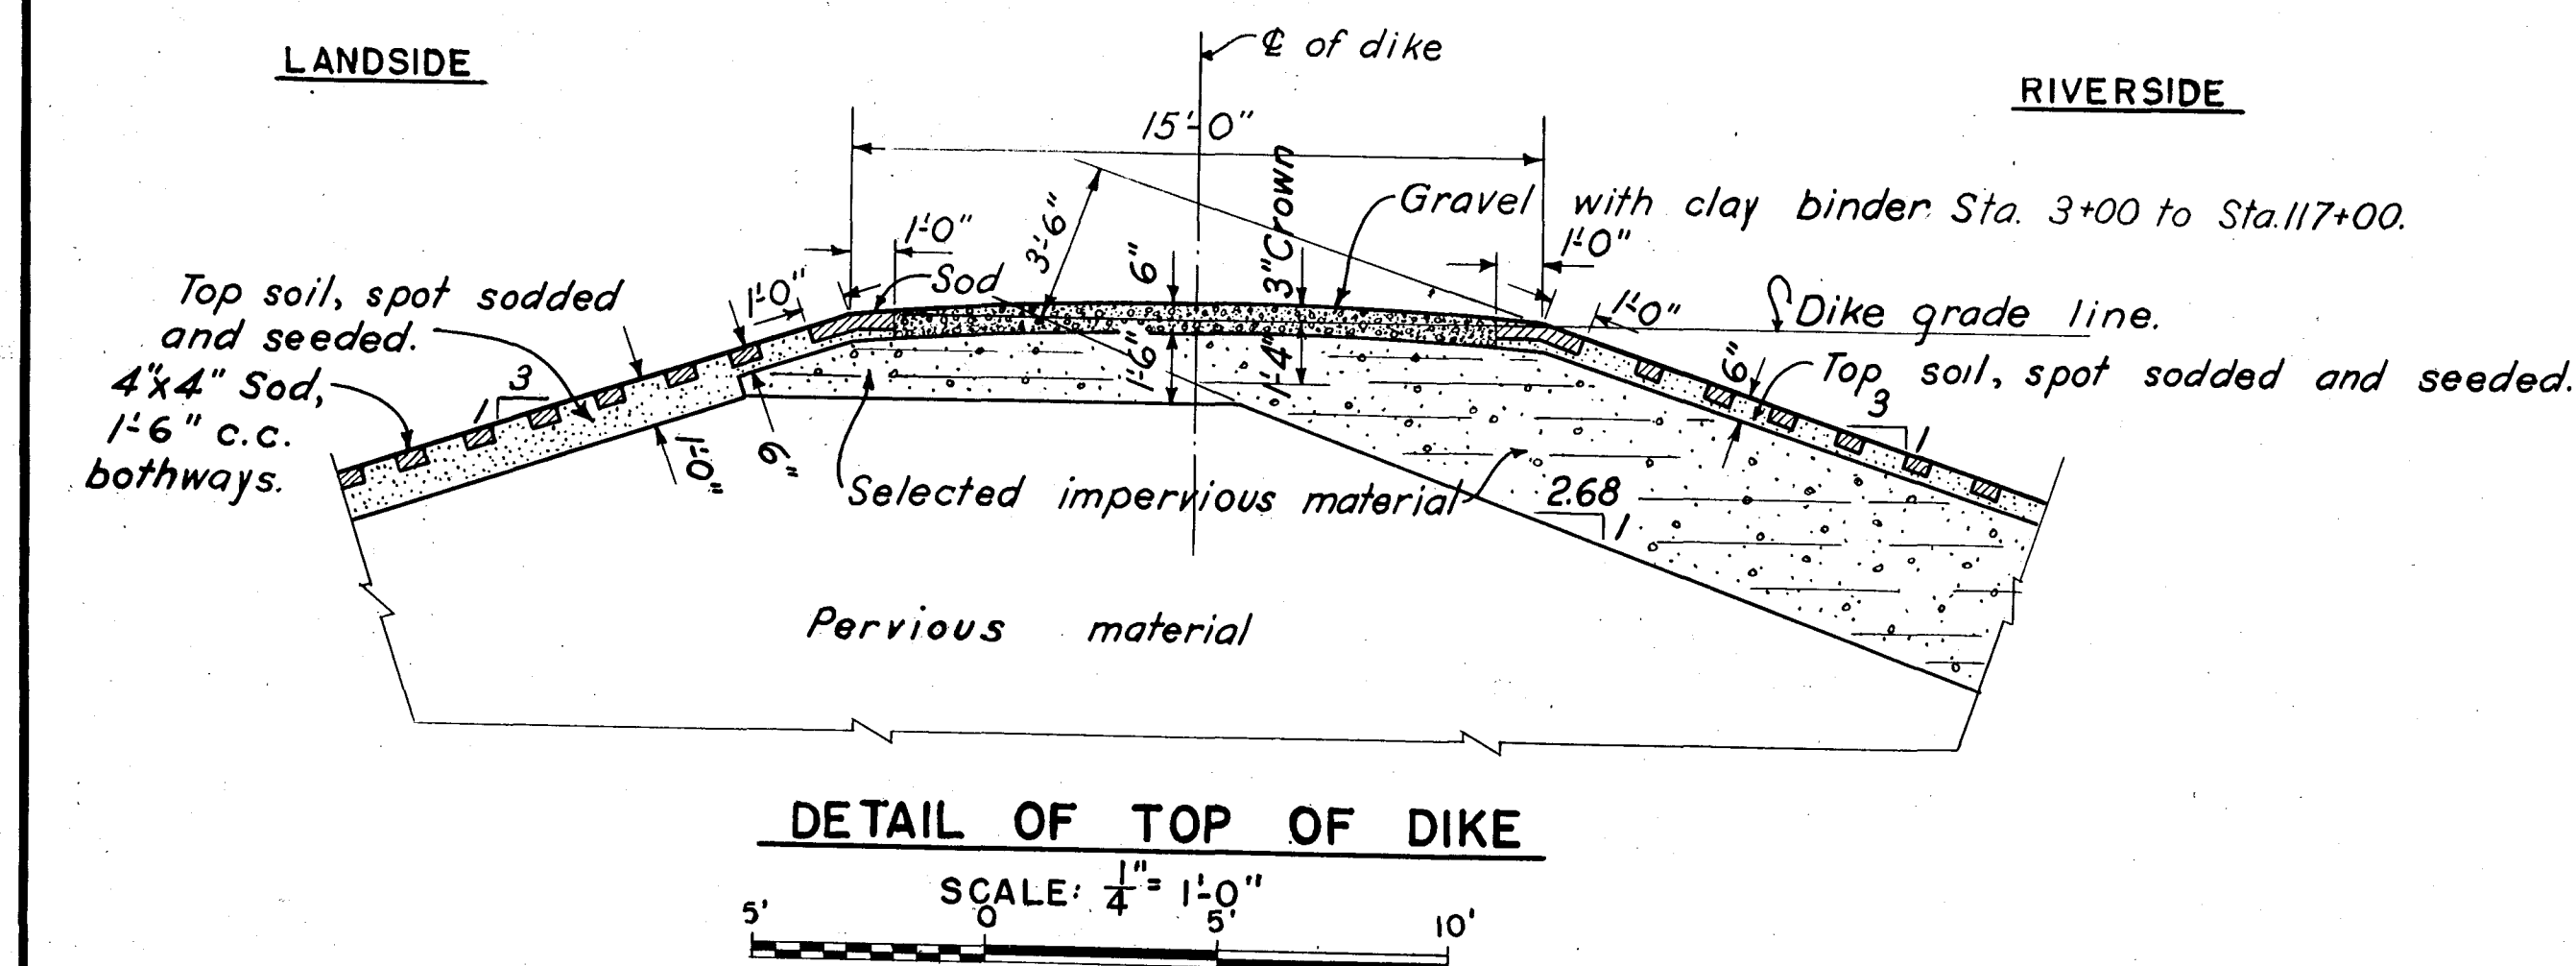
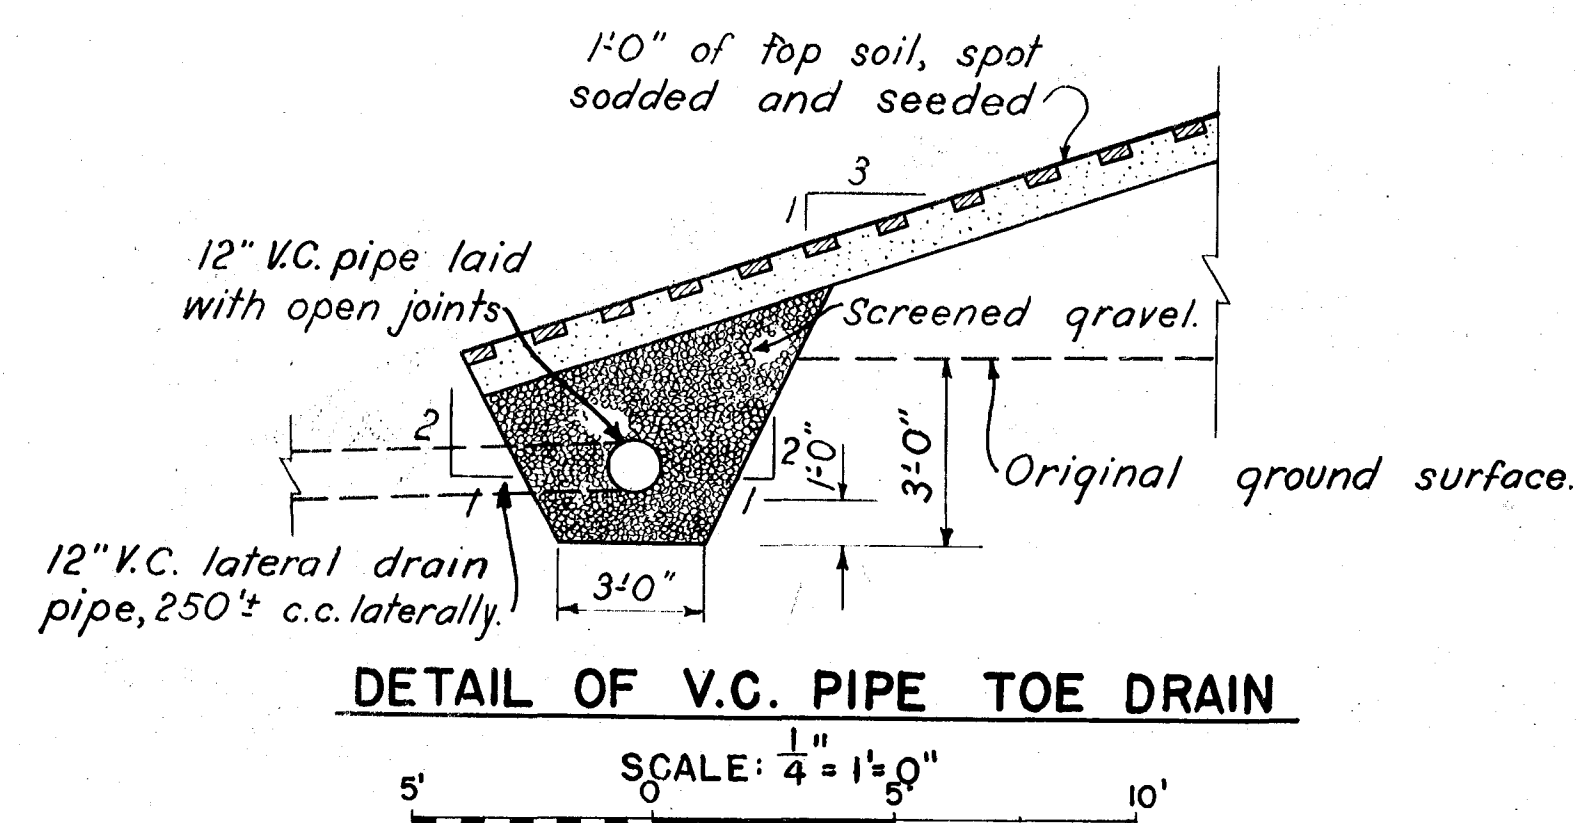
Elevations refer to Mean Sea level datum.  
For general plan see Sheet No. 3.  
Existing 6" layer of top soil from sta. 78+00 to sta. 117+00 adequate. This section to be repaired only.  
For profile of drainage ditch and toe drain trench see Sheet No. 8.
